Inspection Report

Your Inspection Property
CALGARY AB T2X 0N7

Date: 11/14/2016	Time: 01:00 PM	Report ID: 0000
Property: Your Inspection Property CALGARY AB T2X 0N7	Customer: Mr. and Mrs. First Name Last Name	Real Estate Professional:

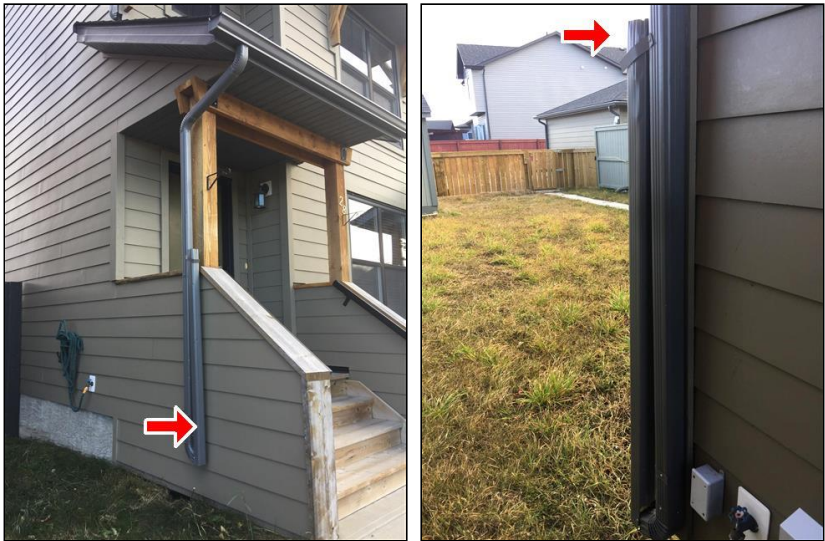
1.3 Figure 1(Picture) Front
Downspout

FYI: Downspouts should extend 6ft away from the foundation wall to prevent moisture retention. I recommend keeping all downspout discharge on the ground and directed away from the home.

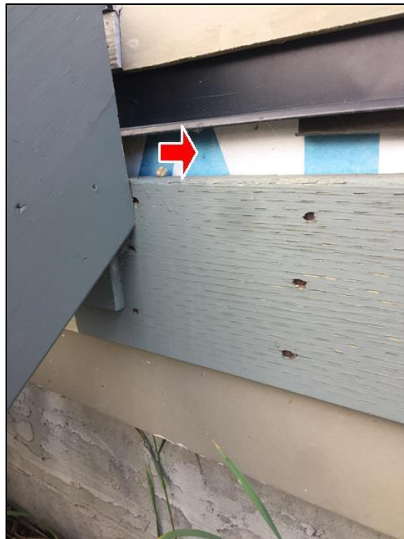
2.0 Figure 1(Picture) Exposed House Wrap

Wall Cladding material is missing behind backyard entry stairs. This exposed area can be used for future builds such as a deck.

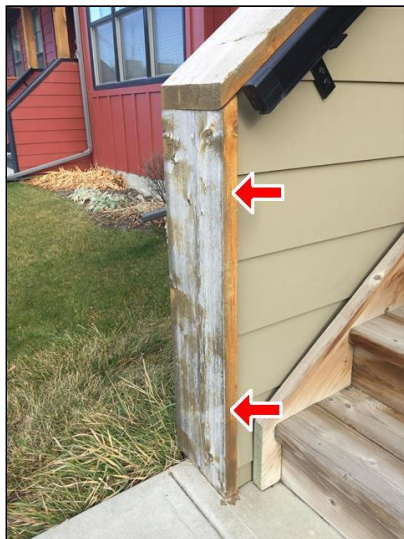
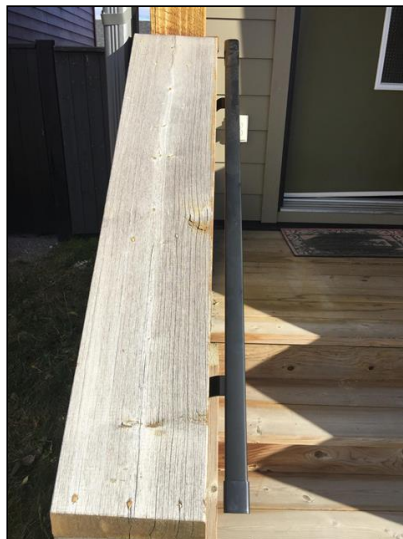
(1) Wood finish on exterior porch requires weather proof sealant. Moisture can wick through the vegetation and concrete causing deterioration.

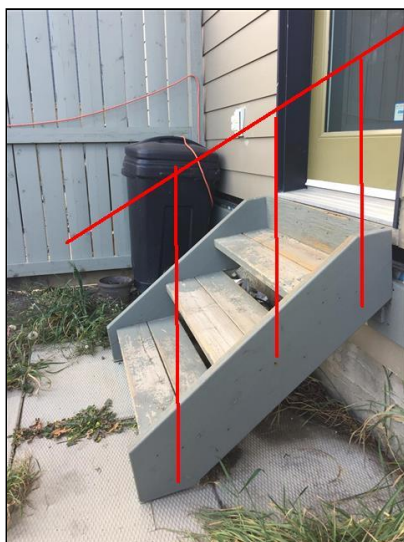
2.3 Figure 3(Picture) Missing Handrail

(2) Back staircase is missing an adequate hand rail. This is a safety hazard for egress during bad weather conditions. Staircase is not adequately attached to the structure and is in direct contact with ground.

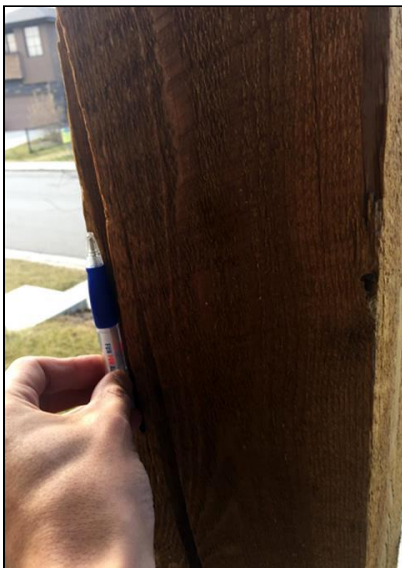
(3) Front entrance, right side porch column (wood) is deteriorating. Elongated cracks allow for moisture to wick deeper into the wood causing fatigue which could result in failure.

2.3 Figure 6(Picture) Comparison Crack

2.3 Figure 7(Picture) Wood Deterioration

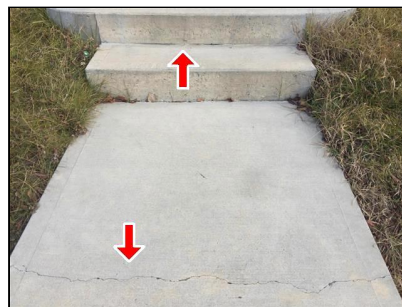
2.4 Figure 1(Picture) Front Walkway

(1) Front Stair case is poured concrete which is cracked in various areas. this can be caused by settlement as well as seasonal weather changes. I recommend monitoring cracks for future movement to prevent a tripping hazard.

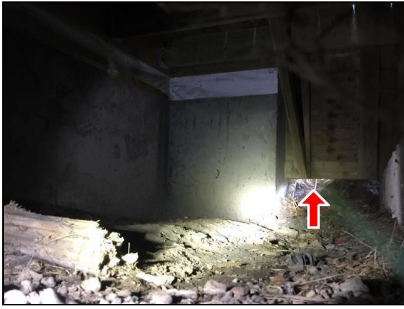
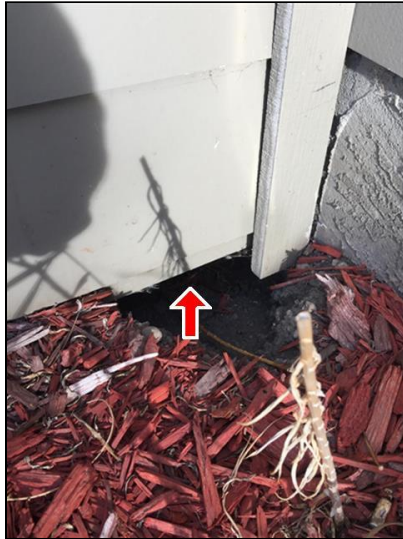
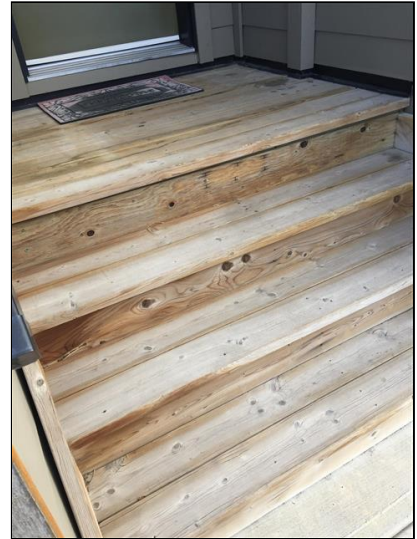
(2) Under Front Porch is sloped negatively causing erosion of ground soil which then directs water to the lowest point underneath. As water settles stagnantly it causes high moisture below which is causing the stair case to deteriorate faster. I recommend raising the grade on both sides of the entry staircase to prevent pocketing to continue.

2.4 Figure 2(Picture) Opening Under Stairs

2.4 Figure 3(Picture) Drainage Right Porch

2.4 Figure 4(Picture) Front Stairway

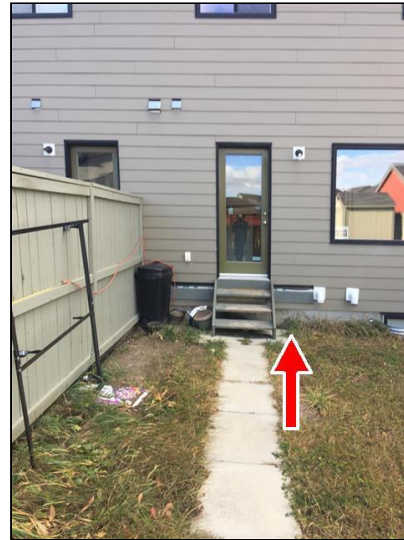
2.4 Figure 5(Picture)

(3) Porch Negative Slope. Back Lawn slopes toward the foundation. Grade should be raised in various areas to promote water to shed away from the foundation wall.

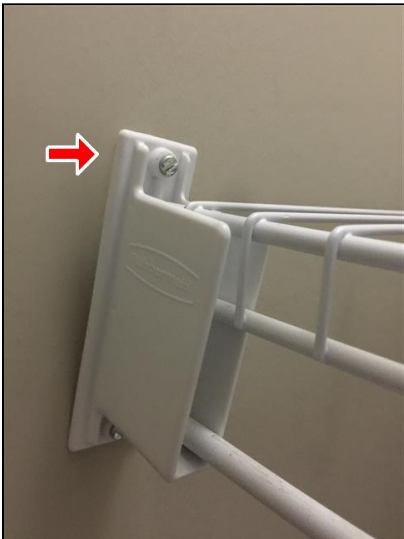
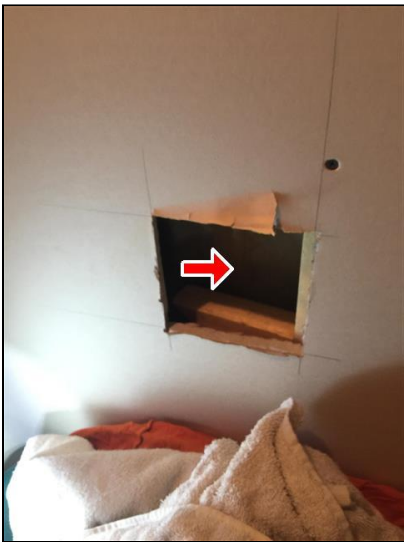
(1) Various areas are evident of wall damage. Exposed holes in the house promote moisture transfer and thermal bridging to other areas. Damaged shelves reduce the load capacity of its function.

4.1 Figure 1(Picture) Upstairs Bedroom

4.1 Figure 2(Picture) Bedroom Closet

4.1 Figure 3(Picture) Damaged Shelf

4.1 Figure 4(Picture) Laundry Room

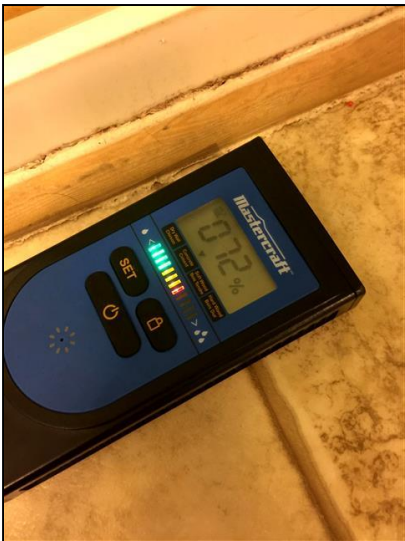
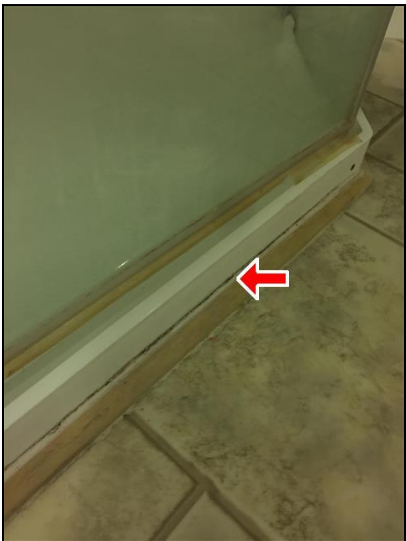
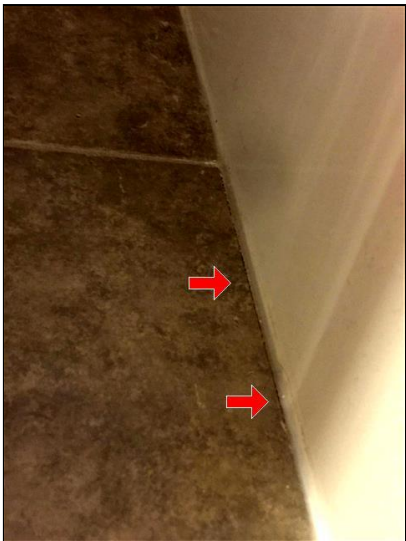
Multiple bathroom tubs silicone caulk along floor and tub are deteriorated. It is essential to routinely maintain the seal around the bathtubs to prevent moisture from damaging surround materials.

4.2 Figure 1(Picture) Basement Bathroom

4.2 Figure 2(Picture) Basement Tub

4.2 Figure 3(Picture) Shared Bathroom Tub

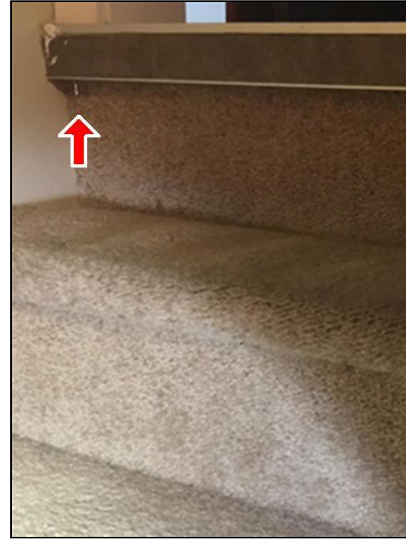
4.3 Figure 1(Picture) Basement Staircase

Exposed nail on staircase to the basement. Exposed nails are safety hazards and should be repaired by carpet and flooring professionals.

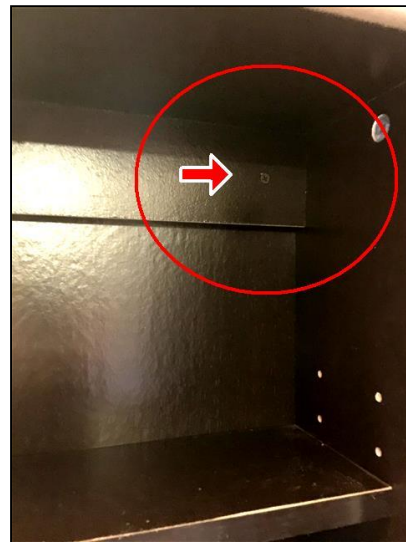
4.4 Figure 1(Picture) Bathroom Cabinet

(1) Shared Bathroom cabinet is attached with drywall screws only at the top. Cabinets should be installed on center of wall studs using adequate fasteners. Cabinet is not secured to the wall on the bottom.

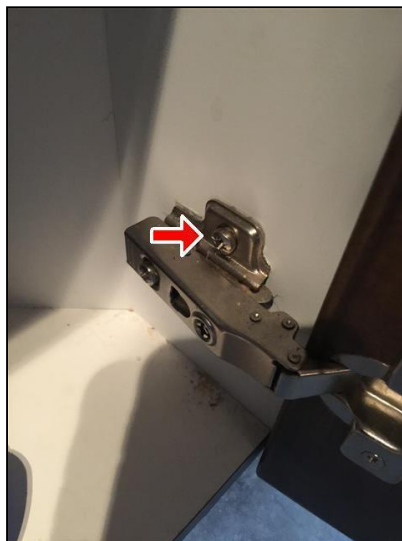
4.4 Figure 2(Picture) Kitchen Cabinet

(2) Loose hinges in kitchen cabinets, this is common wear and tear for a home of this age. Recommend repair to prevent further damage to door components.

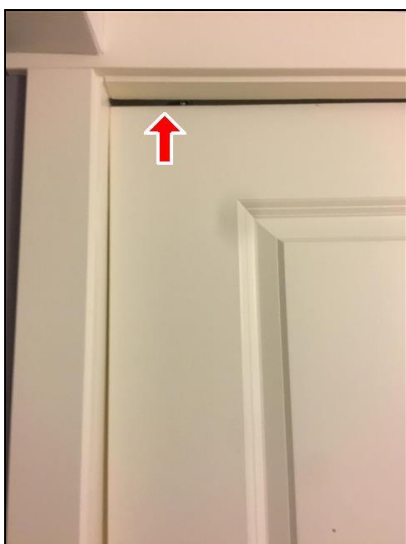
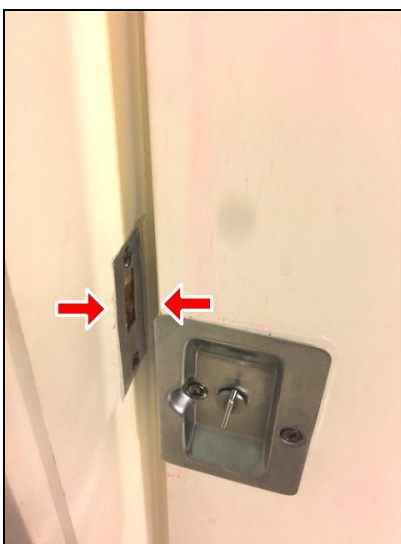
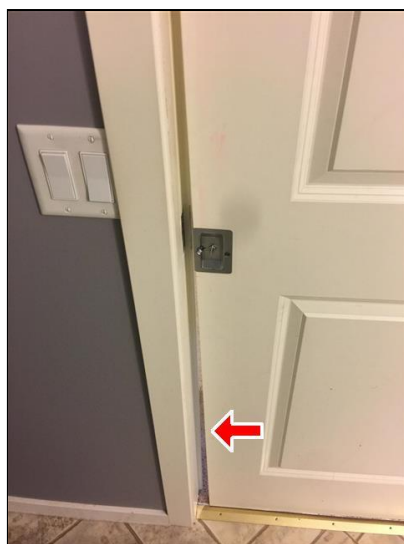
(1) Basement bathroom door top hinge is damaged, it is not adequately aligning the lock connection. Recommend a doors expert to access and repair.

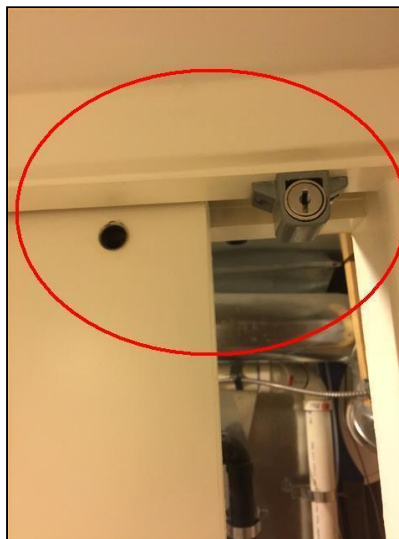
4.5 Figure 4(Picture) Laundry Room Lock

(2) Laundry room door has a lock system attached at the top. I do not recommend locking this door as access to the emergency shut off equipment.

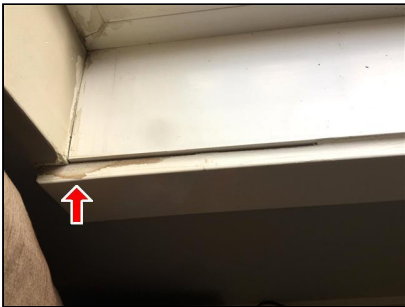
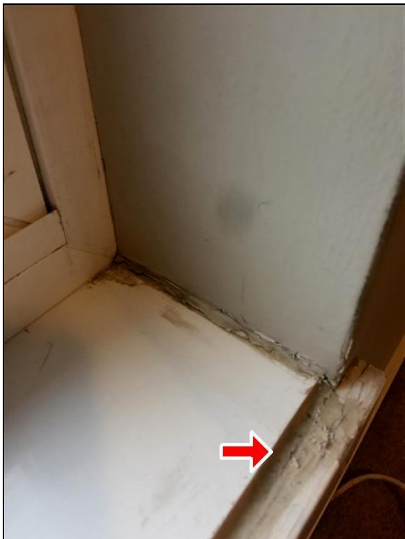
Multiple windows sills are damaged from moisture intrusion in the wood. Monitor open windows during wet seasons. Tested for moisture and came out dry at the time of inspection.

4.6 Figure 1(Picture) Master Bedroom

4.6 Figure 3(Picture) Wood Deterioration.

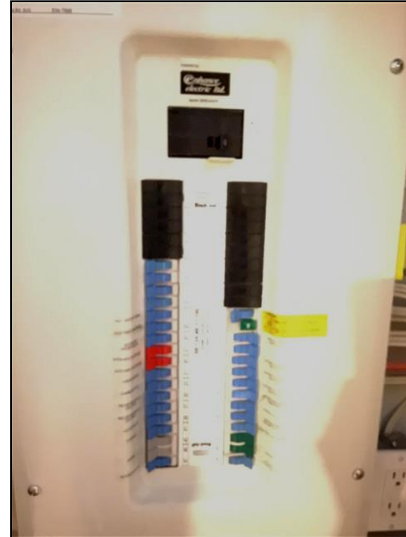
5.2 Figure 1(Picture) Distribution Panel

(1) The main panel box is located in the basement bedroom. Recommend a certified electrician to confirm all the breaker tags are correct.

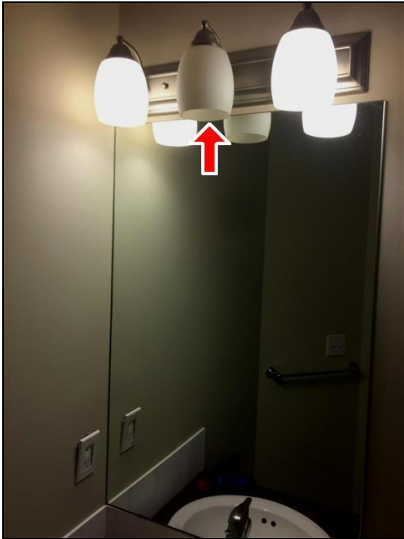
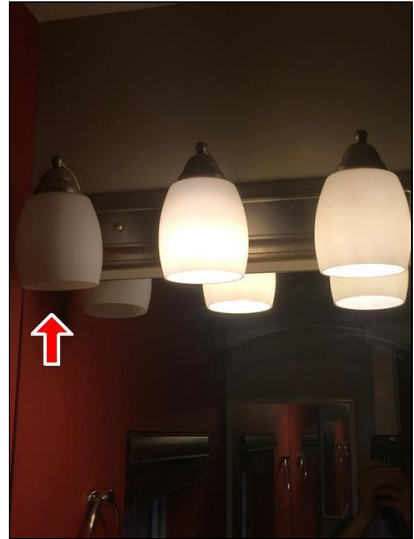
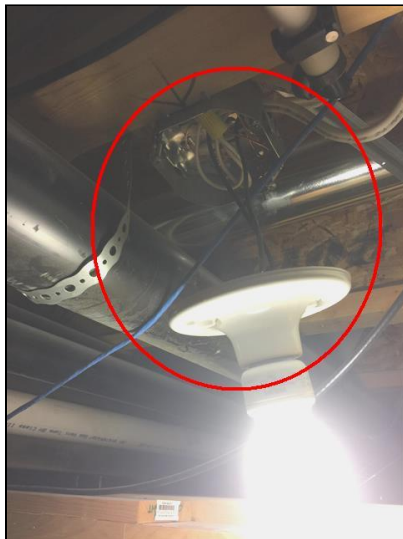
(1) Various Bulbs are not functional and require replacement or repair. I recommend a professional electrician to access and repair.

5.4 Figure 1(Picture) Half Bathroom

5.4 Figure 3(Picture) Shared Bathroom

5.4 Figure 4(Picture) Laundry Room

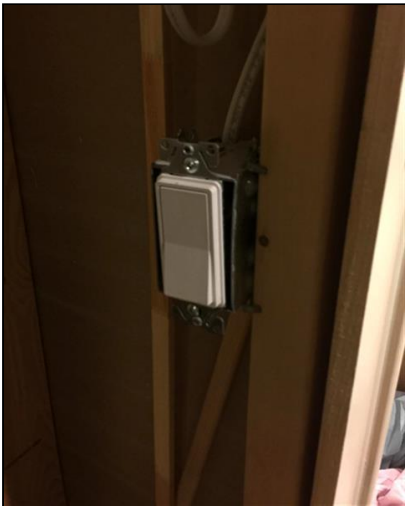
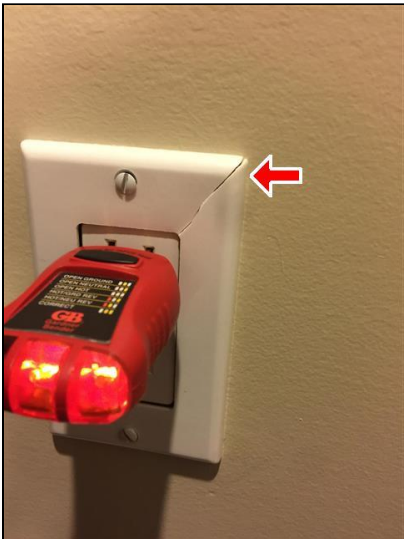
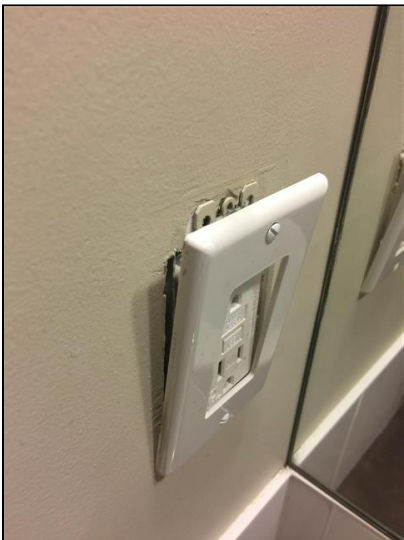
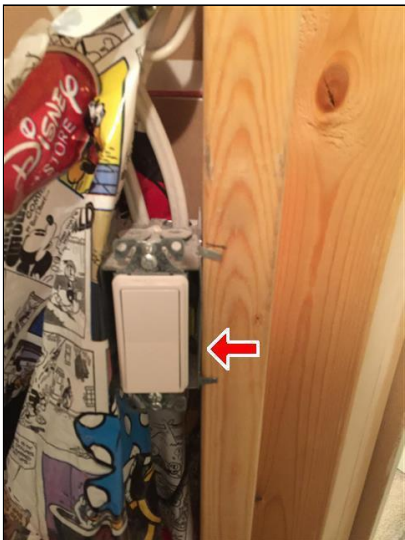
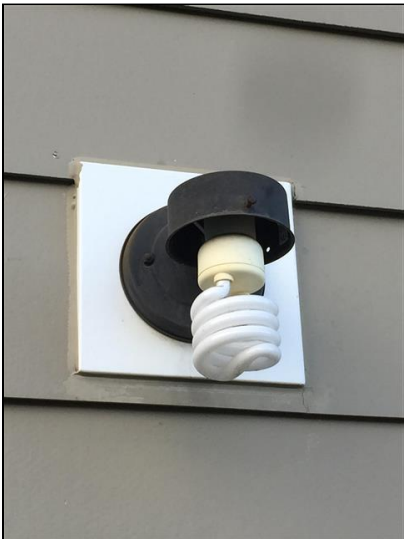
(2) Various Locations are missing covers for receptacles and switches. There are damaged covers also. Recommend qualified electrician to repair and replace damaged and missing cover plate to prevent shock, electrical damage, and potential fire hazard.

5.4 Figure 5(Picture) Laundry Room

5.4 Figure 9(Picture) Basement Bathroom

5.4 Figure 10(Picture) Furnace Room

5.4 Figure 11(Picture) Back door Light

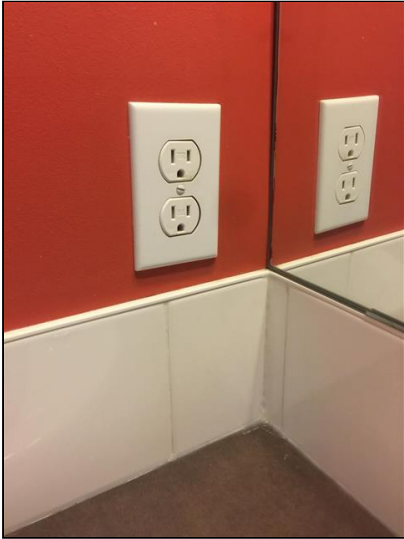
GFI receptacles should be installed in areas exposed to water sources. Using GFCI protect the users incase of shorting, or overcurrent, It is a safety upgrade and is highly recommended to have accessed by certified electricians.

5.5 Figure 1(Picture) Shared Bathroom

5.5 Figure 3(Picture) Kitchen Island

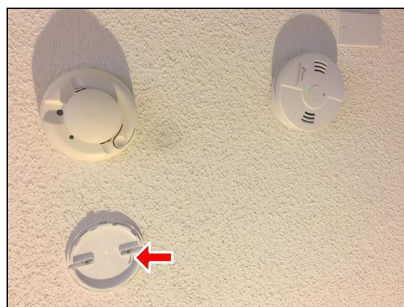
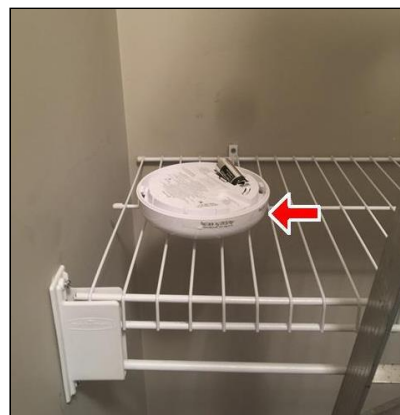
Smoke detectors are located on all levels of the home. Smoke detection system should be tested upon move in.

5.7 Figure 1(Picture) Missing Detector

5.7 Figure 2(Picture) Bedroom Closet

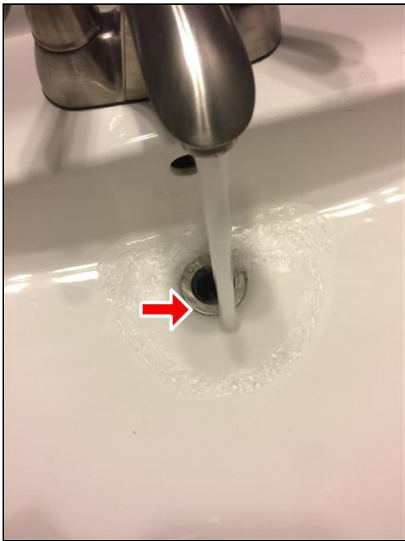
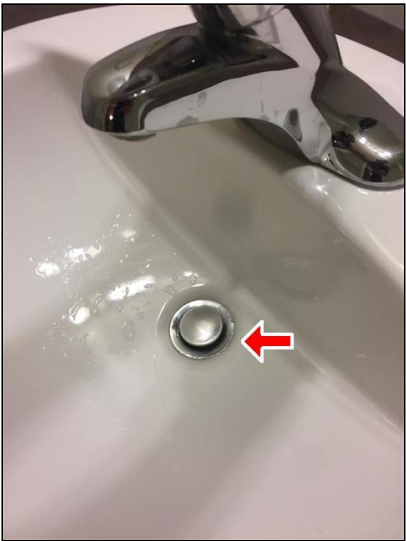
Various sinks are missing stoppers, others do not plug in when activated.

6.1 Figure 1(Picture) Half Bathroom

6.1 Figure 2(Picture) Shared Bathroom

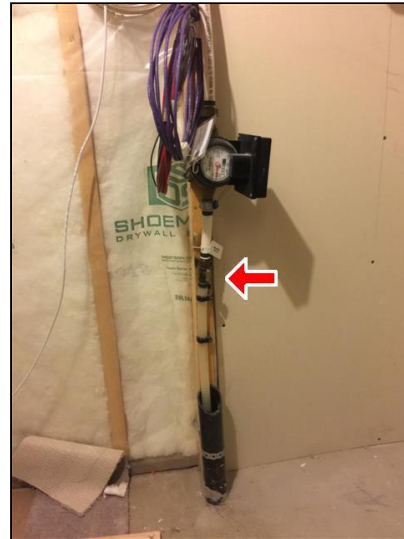
6.3 Figure 1(Picture) Furnace Room

Main water shut off is located in the furnace room. It is recommended to turn off main water supply when leaving the city for extended periods of time to as many insurance policies do not cover damages caused by main water supply leaks.

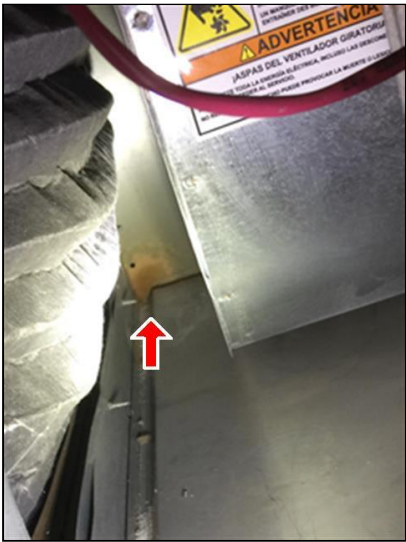
7.0 Figure 1(Picture) Corrosion in Furnace.

Signs of corrosion in the fan chamber. This can be caused by condensation of hot air in the system. Also could be moist air passing through the air filter. I recommend a certified HVAC specialist to advise and access root cause.

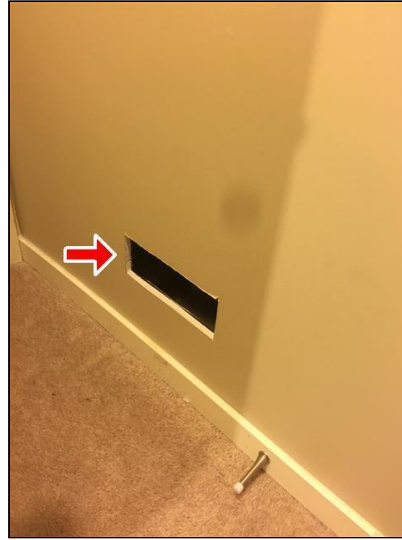
7.3 Figure 1(Picture) Basement Hallway

Various locations in basement are missing ventilation cover. Exposed ducts allow or debris to access system.

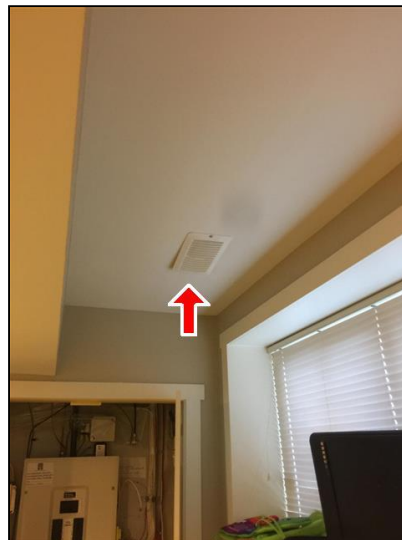
7.4 Figure 1(Picture) Basement Bedroom

No heat source or window in laundry room. Basement Bedroom heat register is located on the ceiling of the bedroom. For adequate heating within the basement it is recommended that the duct be relocated to 6 inches above the floor. Basement bedroom without window does not have a cold air return.

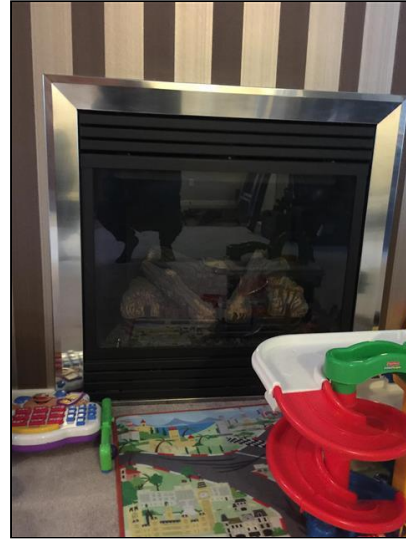
7.7 Figure 1(Picture) Gas Fireplace

Gas fireplace did not function when tested at the time of inspection. I recommend a HVAC specialist to advise.

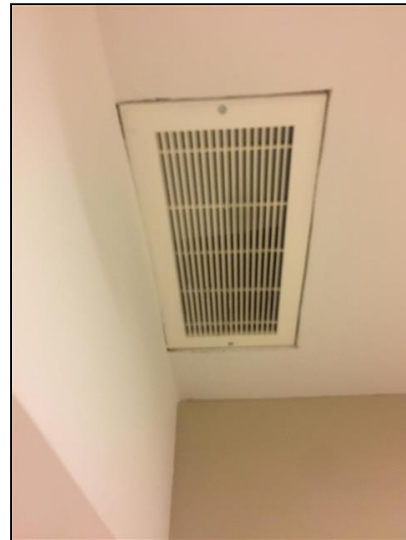
7.10 Figure 1(Picture) Basement Ceiling

(1) Cold air return on the ceiling in the basement. Cold air return on the ceiling removes hot air from the area and cold water remains low not providing uniform distribution of air.

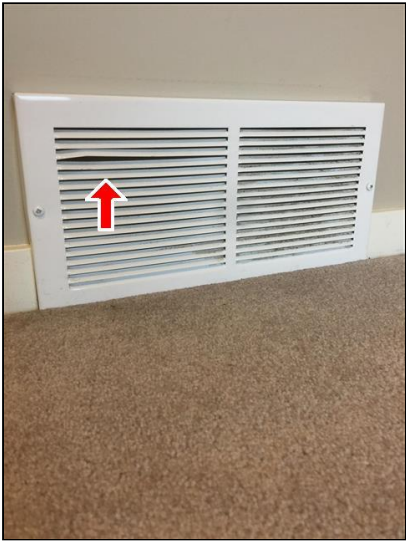
7.10 Figure 2(Picture) Masterbedrom

(2) Grill damaged in mastered room.

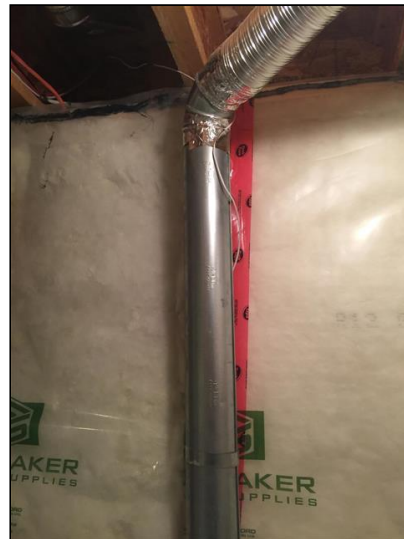
Laundry Dryer duct is unable to carry lint to the outside due to the configuration of the piping. it is highly recommended to frequently clean out the lint in the dryer duct closest to the unit. it is a fire hazard when lint accumulates and restrict a sufficient path for the hot air to escape.

8.4 Figure 1(Picture) Laundry room.

8.4 Figure 2(Picture) Extension Dryer duct

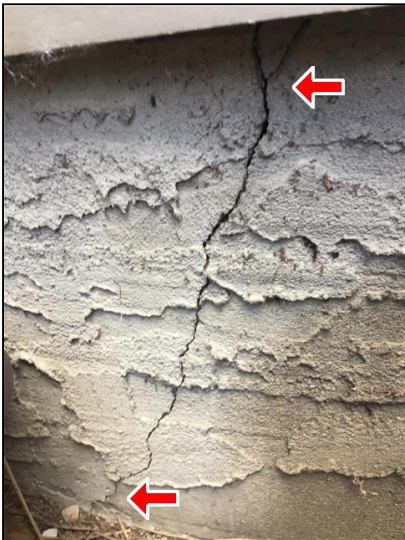
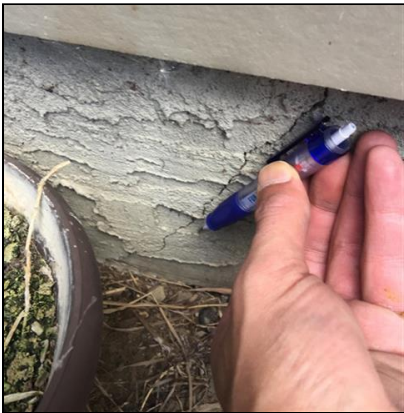
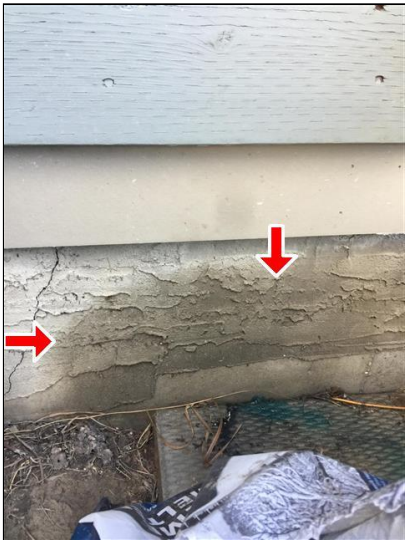
Crack in foundation wall are common during the settlement process. Cracks still should be sealed with wearproof epoxy to prevent moisture to damage foundation walls from the interior. Signs of moisture near the crack. Low Point in soil conditions allow for water to pool near the foundation wall. Recommend raising grade in this location to redirect rain water.

9.0 Figure 1(Picture) Foundation Crack

9.0 Figure 3(Picture) Moisture Foundation

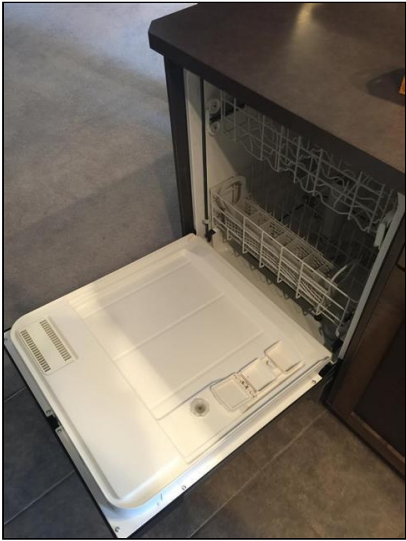
10.0 Figure 1(Picture)

Functional when tested, do not run dry as it can damage the heating elements in the unit.

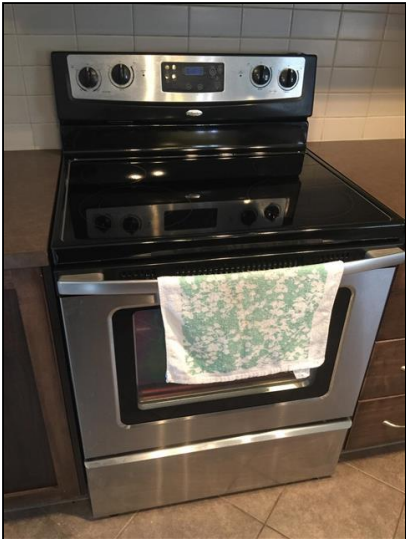
10.1 Figure 1(Picture)

Tested and all burners and stove are functional
